Cedar Island, Pike and Eagle Lakes Nutrient TMDL Five Year Review

Prepared for:
Shingle Creek Watershed Management Commission
3235 Fernbrook Lane
Plymouth, MN 55447
shinglecreek.org

WENCK Associates, Inc.
7500 Olson Memorial
Highway
Phone: 763-4252-6800
Fax: 952-831-1268
www.wenck.com

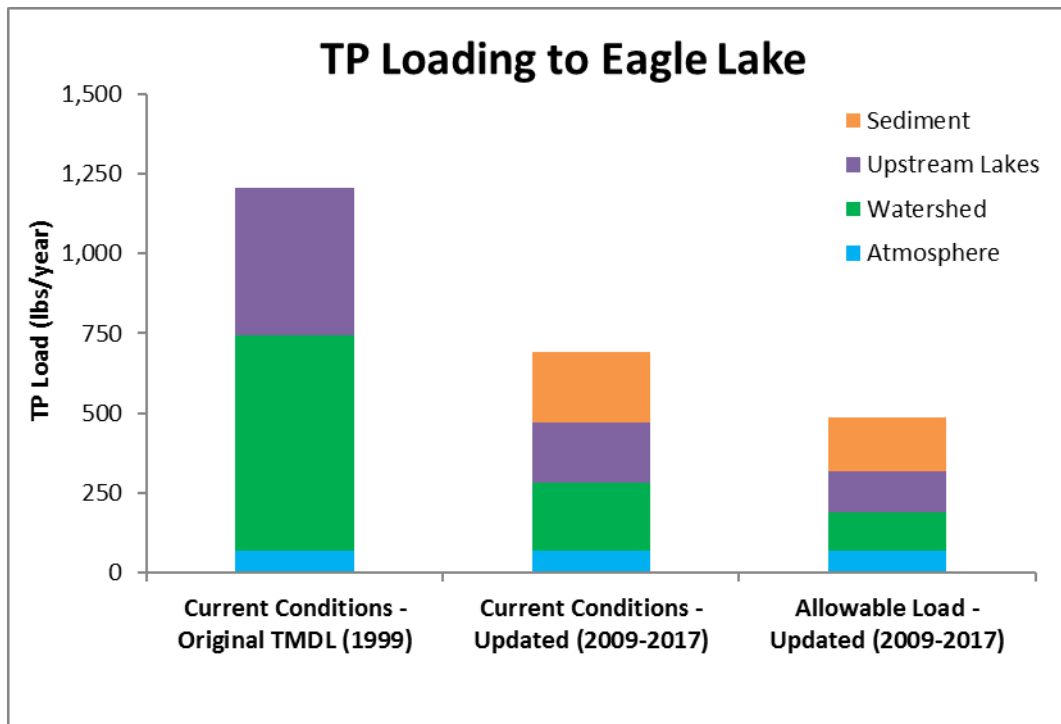
Figure 3-3. Current conditions and updated allowable load targets for Eagle Lake.

The original TMDL models used 1999 as a base year for estimating the existing nutrient loading and TMDL allocations for Eagle Lake. The original TMDL model called for watershed and upstream lake TP load reduction goals of approximately 264 lbs/year and 221 lbs/year, respectively (Table 1-1). Recent in-lake monitoring, stream monitoring, and sediment core collection and analysis have greatly improved our understanding of the current condition TP budget for Eagle Lake. The updated lake response model suggests upstream impaired lakes (Cedar Island and Pike Lakes) will need to achieve State water quality standards. Improvements in these lakes should result in TP load reductions to Eagle Lake of approximately 66 lbs/yr. Finally, watershed loading will need to be reduced by approximately 88 lbs/year and sediment release of phosphorus by 48 lbs/year (Table 3-1). Figure 3-2 shows how our understanding of the existing and allowable TP loads in Eagle Lake have changed since the original TMDL study.
